City of Alexandria Storm Sewer Capacity Analysis (CASSCA)

Taylor Run Condition Assessment

PREPARED FOR: City of Alexandria, CH2M Hill
PREPARED BY: Michael Baker Jr., Inc.
DATE: June 27, 2013 (Revised May 26, 2015)

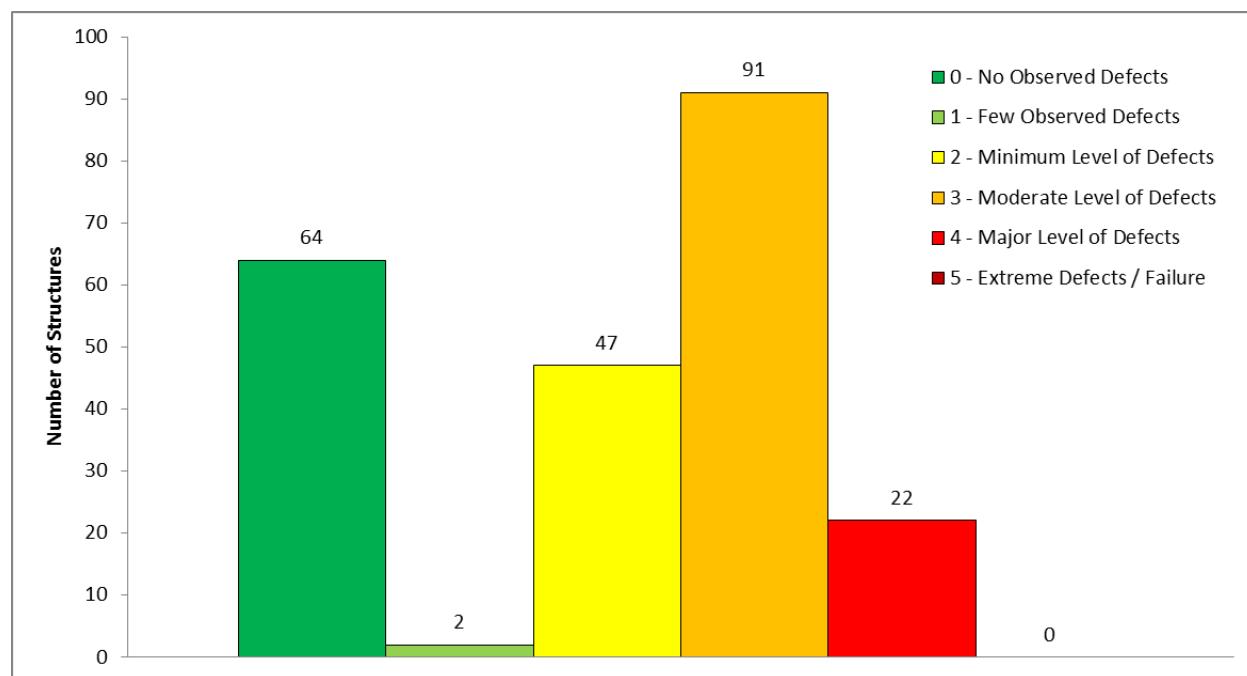
Figure 1. Structure Inspection Summary.

As part of this inspection task, 226 storm structures were inspected in the Taylor Run watershed. Figure 1 shows the number of structures identified within each defect category identified in the previous section. Figure 2 is provided to show the geographic location of each structure within the Taylor Run watershed, color coded to its defect category. The average condition score of the storm structures was 35 (Minimum). Twenty-two (22) structures had scores between 61 and 80, placing them in the major category. About 30% of the structures showed few to no defects, while approximately 60% of the structures ranked in the minimum to moderate defect categories. None of the inspected structures had extreme defects.

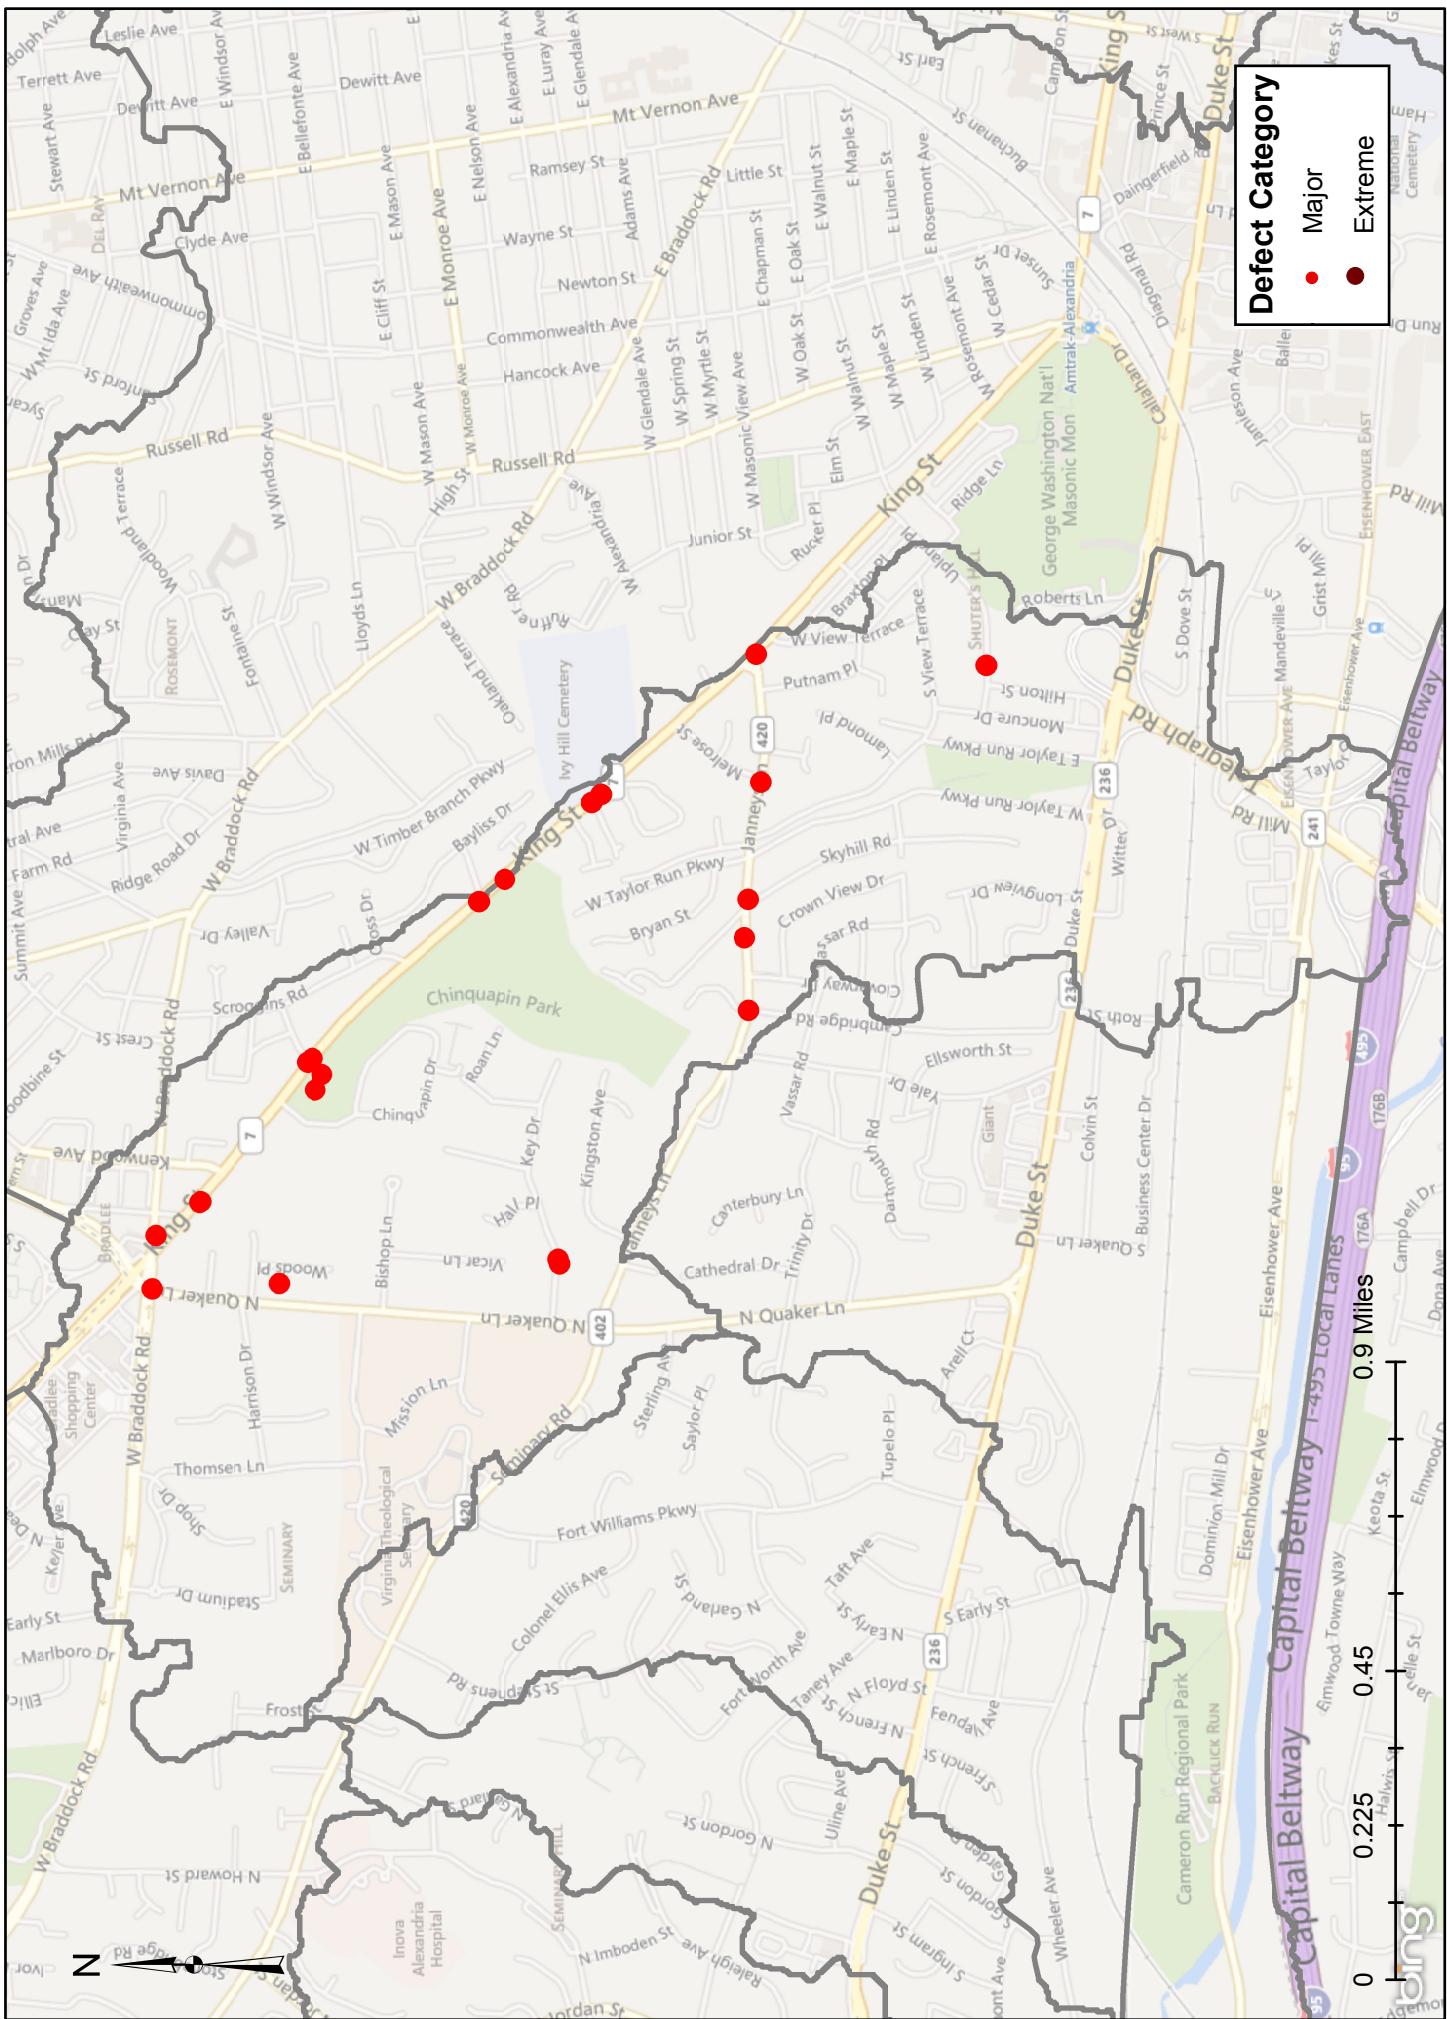
Figure 3. Location of Storm Structures in the "Major" and "Extreme" Categories (Color coded by Severity of Defects).

Figure 3 displays the location of the structures classified with major damage only. No extreme defects were observed within Taylor Run watershed. From the figure, the corridors of King Street and Janneys Lane seem to have clusters of structures with high defect scores. The inspection results of the structures were broken down by structure component for further detailed condition assessment. Table 2 lists the number of observed defects by component and severity. Note that the table shows a count of the number of defects found in each component and their respective severity across all structures. Multiple defects may be found in a single component of a structure.

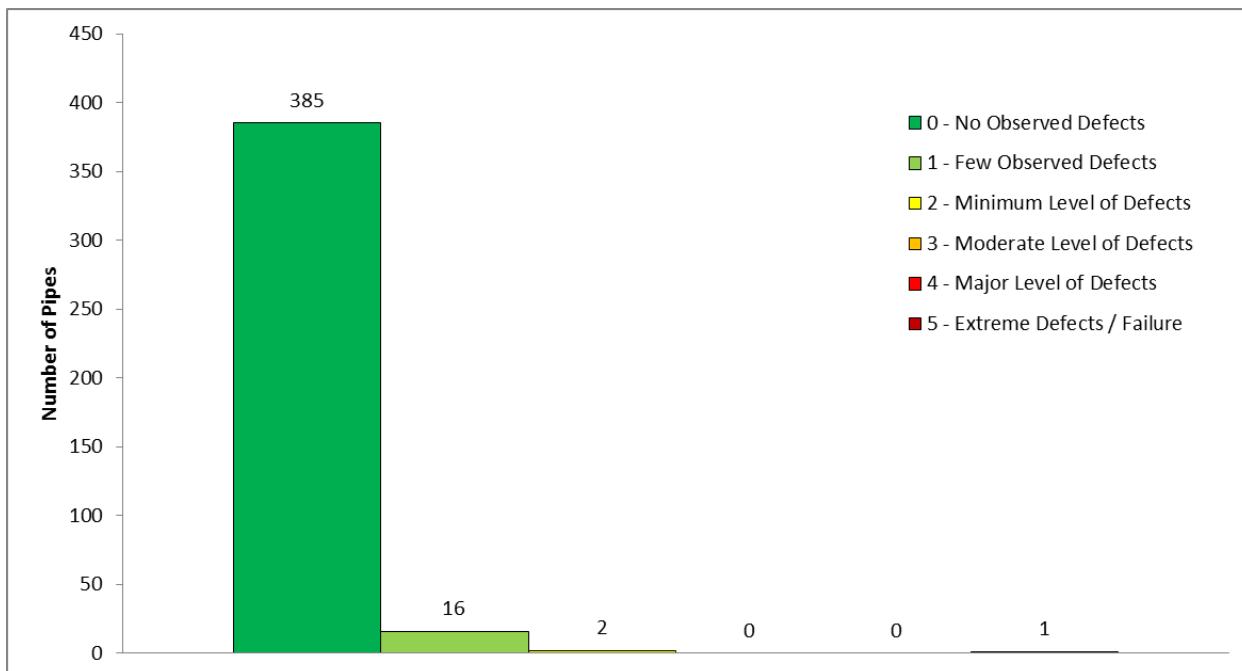
Figure 13. Pipe Lamping Inspection Summary.

In total, 404 storm sewer pipes were inspected in the Taylor Run watershed. Figure 13 shows the number of pipe segments within each defect category. Figure 14 shows a map of the location of each inspected pipeline, color coded by the defect categories identified previously in the memorandum. The average condition score of the 404 storm pipe segments inspected within the Taylor Run watershed was 0.7 (Few to No defects). Inspection results in Taylor Run watershed showed that the pipe segments were observed to be in generally excellent condition, with no defect observed in 95% of the pipes. Sixteen (16) pipe segments were classified as exhibiting few observed defects.
